Bridge Deck Frosting-- Valley Environment

Stewart, C.F. and Sequeira, A.

BRIDGE DECK FROSTING

BRIDGE DECK FROSTING - VALLEY ENVIRONMENT

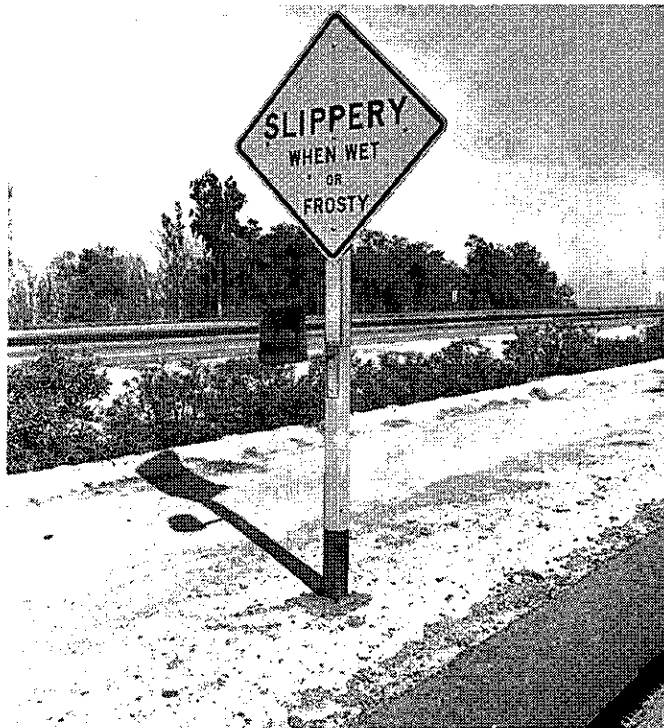
FIGURE 1

The present motorist warning system of impending frost danger is a standard "Slippery When Wet or Frosty" metal sign, Figure 1, which is sometimes illuminated at night by a flare pot.

Standard Motorist Warning Sign

This type of sign is ineffective, primarily because it is continuously visible to the motorist, even in the summer time, and as such becomes an accustomed standard fixture along the roadway. When the sign is used exclusively for frost warning, some maintenance people try to restrict its visibility to periods of actual hazardous conditions by covering it or turning it away from sight when the hazard does not exist. But since frosting is almost impossible to predict, even this method leads to ineffectiveness of the sign due to its frequent cry of "Wolf" by often being exposed when there is no frost.

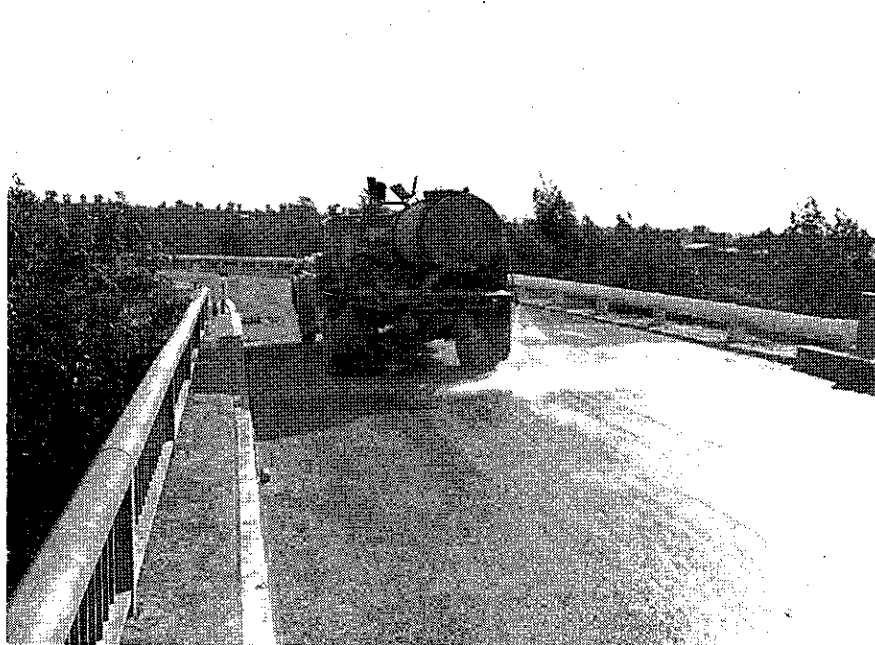
Applying saline solution to a bridge deck
Figure 2

1. When there is a high potential for frosting, a crew will stand by to apply a salt-sand mixture to bridge decks as necessary.
2. The Highway Patrol informs local maintenance personnel after frost has formed on decks.
3. A frost preventive saline solution is periodically sprayed onto the decks. Each application is effective for approximately three days. (figure 2)

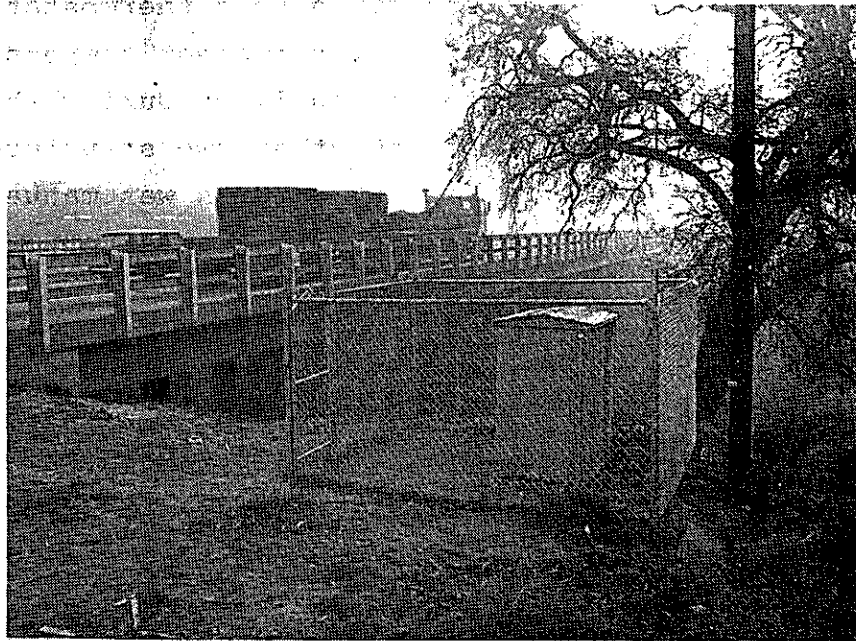
Figure 6

Instrumentation Shed

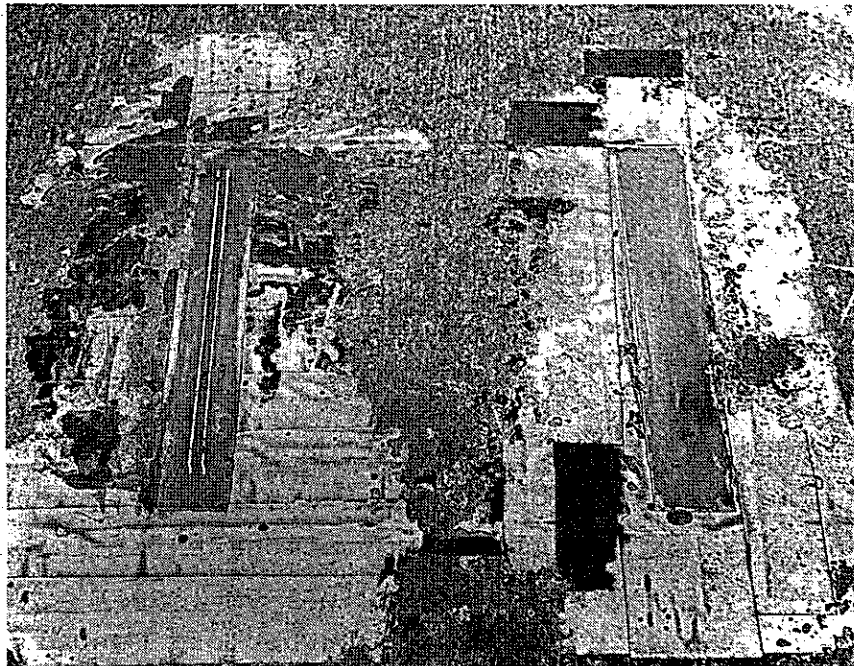
NELSON
Figure 8

The Nelson unit has one set of electrodes in a rectangular housing and a thermostat, factory set at 32°, in a similar housing. Electrodes for the Econolite and Holley are in two separate cylindrical housings. (Figure 8)

DECK SURFACE TRANSDUCERS

ECONOLITE (Transducers for the Holly system are similar)

All systems employ the same basic logic, that is, they measure conductance between a set of electrodes mounted in each of two sensors placed in the deck. A heater, electrically controlled to turn on at 35°, in one set prevents moisture that is present from freezing. Hence, should conditions be favorable for icing, moisture between

one set of electrodes will freeze but will remain liquid between the other set. Since ice has a much lower conductance than does water, a comparison of conductance measurements will show: 1) if moisture is present; and, 2) if ice is present. Also the unheated sensor detects temperatures below 32°.

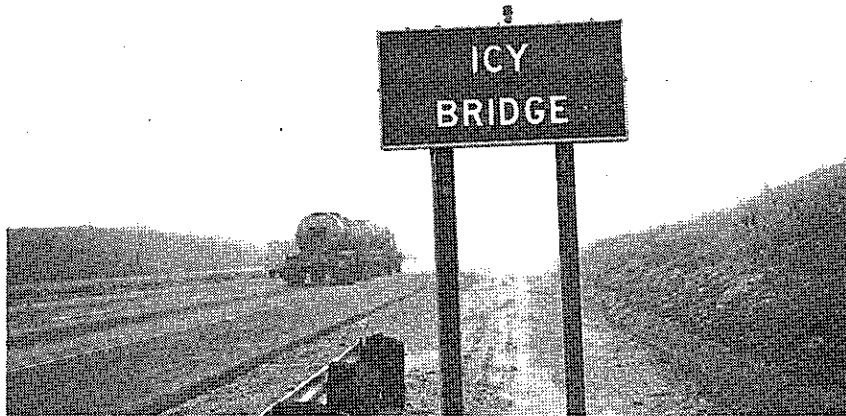
Figure 9

An extinguishable message sign was installed on an approach 600 feet from one of the bridges. Flashing fluorescent tubes illuminated the 8-inch high "ICY BRIDGE" letters of the sign from behind. When the tubes are not lit, the letters blend in with the blank face of the sign, thus making the message indiscernible when the sign is "Off". (Figure 9)

ELECTRIC MOTORIST WARNING SIGN

OFF

ON
(Day)

ON
(Night)

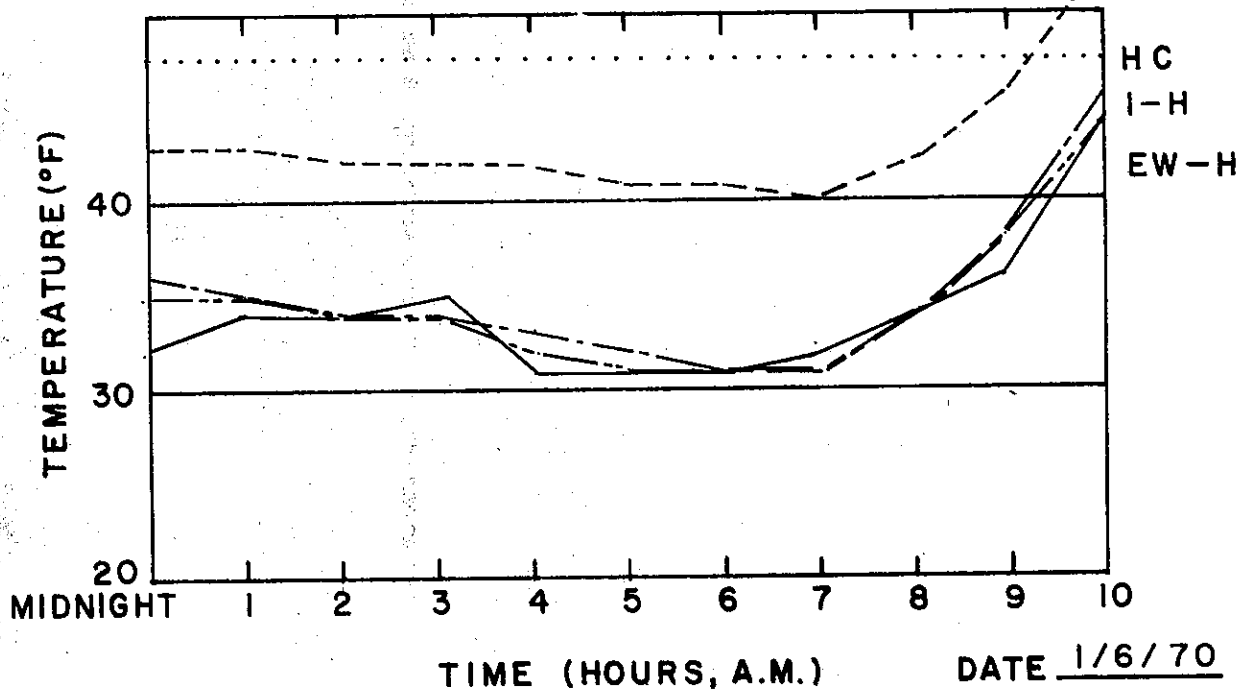
TEMPERATURE AND ICE DETECTION

YOLO CAUSEWAY

- HC = HEATING CABLES
- I-H = ICE HOLLEY + + + +
- EW-H = EARLY WARNING —
- HOLLEY x x x x

HEAT: 10 WATTS/sq. ft. /
